POSTBUCKLING RESPONSE OF GRAPHITE-EPOXY PLATES LOADED IN COMPRESSION

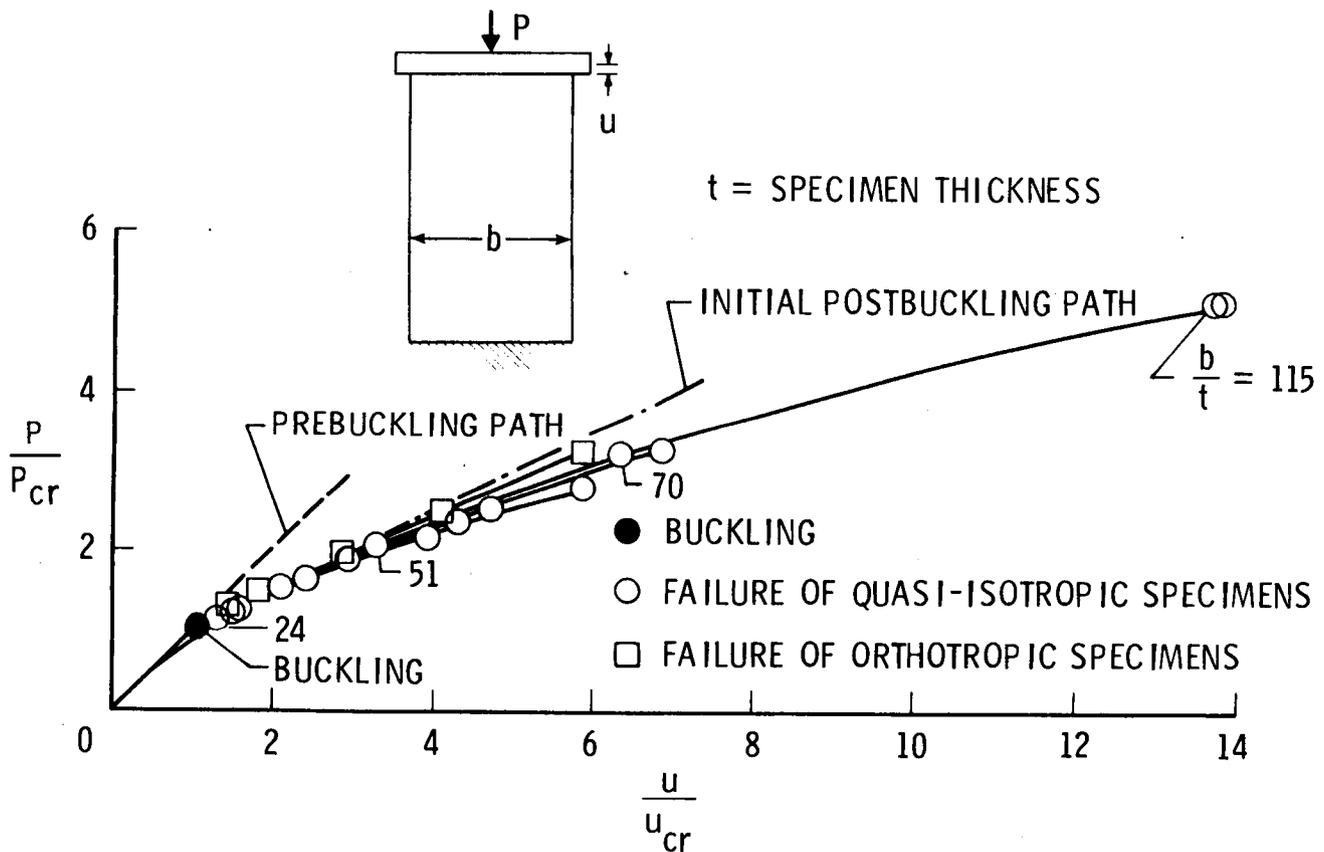
Figure 1

Flat unstiffened rectangular plates were loaded to failure in compression to study their postbuckling behavior (ref. 1). Unidirectional tapes of Thornel 300 graphite fibers preimpregnated with Narmco 5208 epoxy resin (T300/5208) were used to make 16- and 24-ply quasi-isotropic and 24-ply $[\pm 45/0_2/\pm 45/0_2/\pm 45/0/90]_S$ orthotropic plates. The plates were 20 inches long and from 3.5 to 9.0 inches wide. The loaded ends of the plates were clamped and the sides were simply supported.

Load-shortening results from the tests are summarized below in Figure 1. The applied load P is normalized by the buckling load P_{cr} and the measured end shortening u is normalized by the end shortening at buckling u_{cr} . Buckling is indicated by the filled circle and failure is indicated by the open symbols. All specimens had some postbuckling response. Specimens with lower values of width-to-thickness ratio (e.g., $b/t = 24$) failed at applied loads that are slightly higher than the buckling load. Specimens with higher values of width-to-thickness ratio (e.g., $b/t = 115$) failed at applied loads that are several times larger than the buckling load.

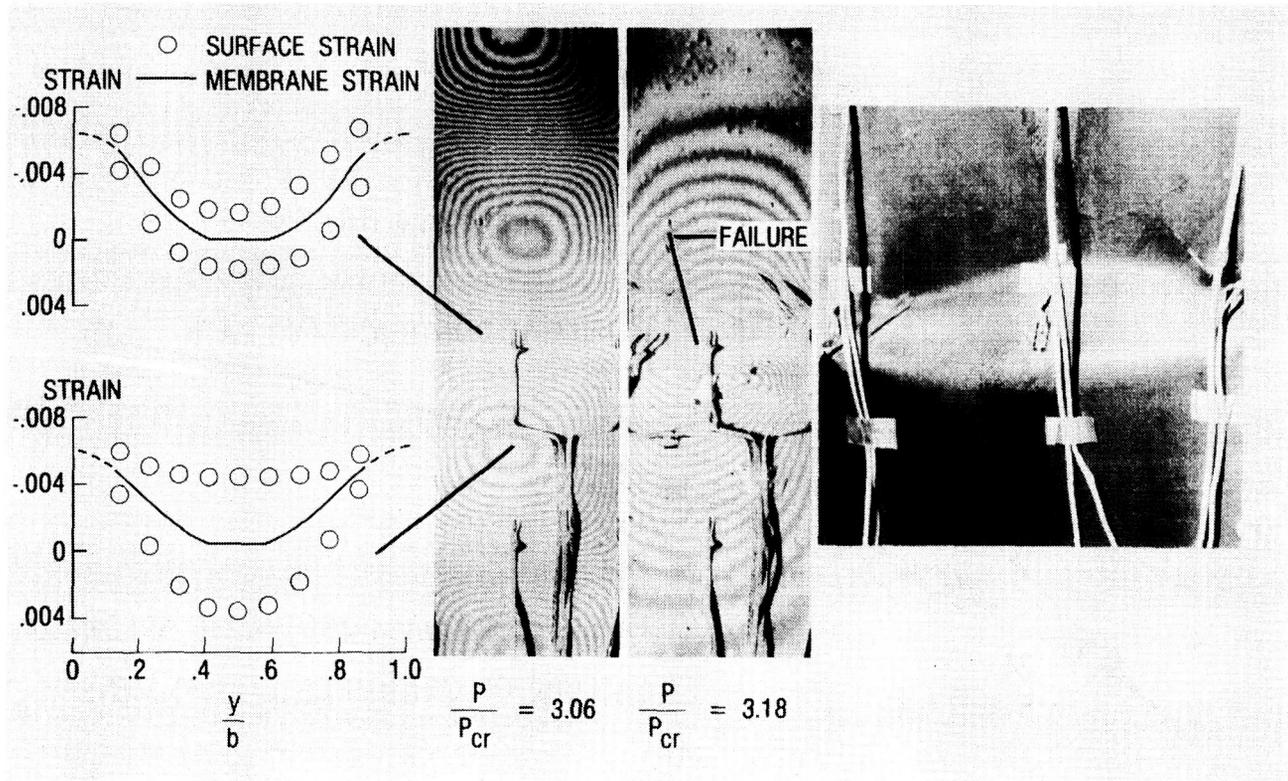
Longitudinal strain distributions across the width of a typical buckled specimen in Figure 1 are shown below in Figure 2 for an applied compressive load of about three times the buckling load. The figures on the left of Figure 2 show typical measured surface strain data from back-to-back strain gages and the resulting computed membrane strains across a nodal line of the buckling mode and across the plate at a point of maximum buckling mode amplitude. These data show that the membrane strains are low in the interior of the buckled plate and high at the edges of the plate.

The buckling mode shape of the typical specimen is represented by the moire-fringe pattern shown in the left photograph. The panel failed along a nodal line of the buckling mode as indicated by the moire-fringe pattern shown in the center photograph. Apparently, the higher membrane strains near the specimen edges couple with the out-of-plane deflection gradients at the nodal line to cause the shear failure shown in the right photograph.

- o Unstiffened laminates fail along buckling-mode nodal lines where interlaminar shear stresses are large.
- o Holes and low-speed impact damage can degrade postbuckling strength if local strains are high enough to initiate and propagate damage.

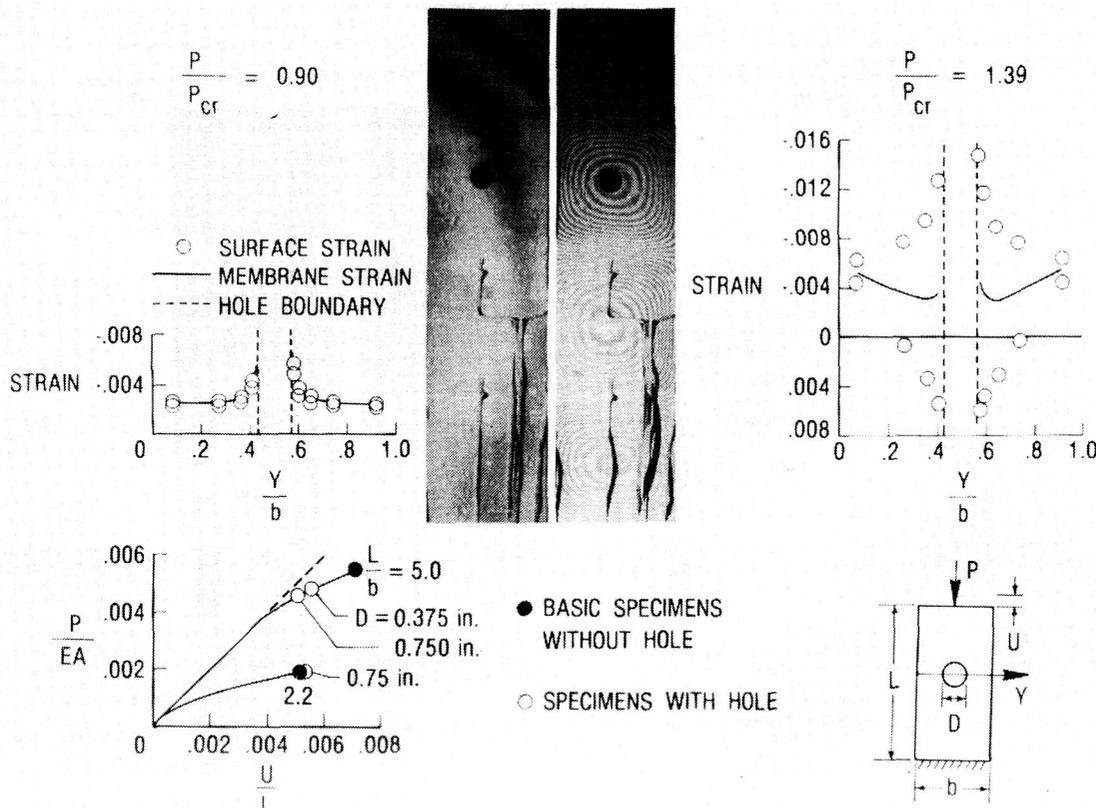
Figure 3

The effects of circular holes on the postbuckling behavior of flat T300/5208 graphite-epoxy plates similar to those described in Figure 1 were studied in reference 1 and some typical results are shown in Figure 3. Back-to-back strain gages were distributed across the specimen along a lateral line (labeled Y on the lower right figure) that passes through the center of the hole. For applied loads P less than the buckling load P_{cr} these strain gages indicate that a membrane strain gradient exists near the hole as shown in the upper left figure. The left photograph shows a moire-fringe pattern of the specimen before buckling and indicates that no out-of-plane deformations have occurred. The right photograph shows a moire-fringe pattern of the buckling mode shape with four longitudinal waves. For applied loads greater than the buckling load, the back-to-back strain gages indicate that the buckling mode shape has caused a severe local bending strain gradient to occur near the hole as shown in the upper right figure.

Measured end shortening results U for typical specimens with various hole diameters D and plates aspect ratios L/b equal to 2.2 and 5.0 are shown in the lower left figure as a function of the applied load P . End shortening is normalized by the plate length L and the applied load is normalized by the plate longitudinal modulus E and cross-sectional area A . The filled circles represent failure of specimens without holes and the open circles represent failure of specimens with holes. The results indicate that a hole had little effect on the postbuckling strength of the low-aspect-ratio specimens but the postbuckling strength of the high-aspect-ratio specimens decreased as the hole diameter increased.

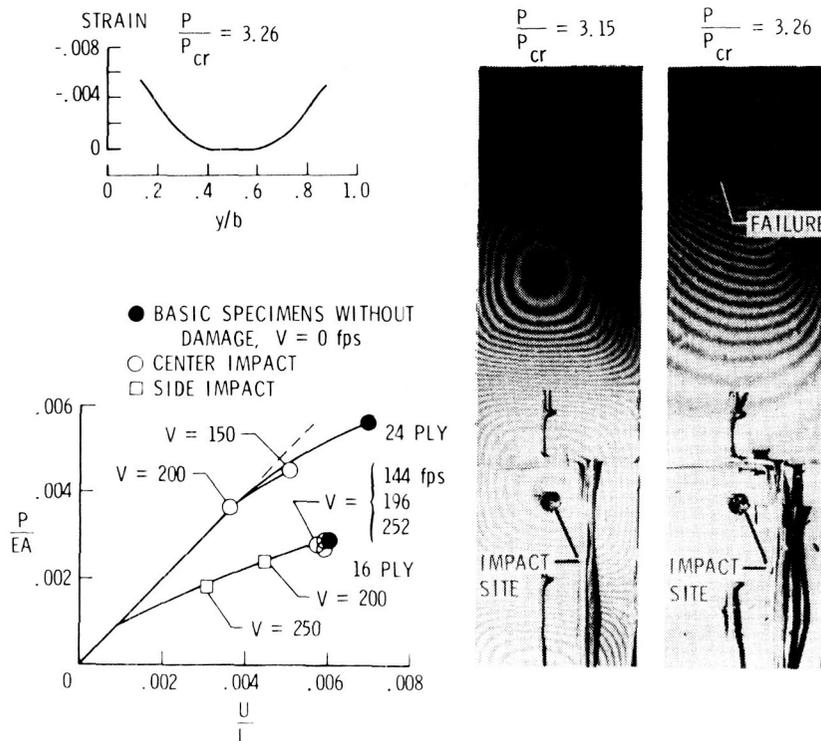
Figure 4

The effects of low-speed impact damage on the postbuckling behavior of flat T300/5208 graphite-epoxy plates similar to those described in Figure 1 were studied in reference 1 and some typical results are shown below in Figure 4. Specimens were impacted with 0.5-inch-diameter aluminum balls at various impact speeds V and then tested to failure. Measured end shortening results U for typical 16- and 24-ply quasi-isotropic specimens are shown in the lower left figure as a function of the applied load P . End shortening is normalized by the plate length L and the applied load is normalized by the plate longitudinal modulus E and cross-sectional area A . The filled circles represent failure of specimens without impact damage and the open symbols represent failure of specimens with impact damage. The open circles represent failure of specimens impacted in the center and the open squares represent failure of 16-ply specimens impacted near a specimen side. The results indicate that impact damage in the center of the 16-ply specimens had little effect on postbuckling strength regardless of the impact speed. The left photograph shows the moire-fringe pattern corresponding to the out-of-plane deformations of a 16-ply specimen loaded to approximately three times the buckling load and the right photograph shows the moire-fringe pattern corresponding to the failed specimen. Failure occurred along a buckling-mode nodal line away from the impact site. The membrane strain distribution across the specimen just before failure is indicated in the upper left figure. Apparently, the strain in the center of a 16-ply specimen is not high enough to cause the impact damage to propagate to fail the specimen. The results also indicate that impact damage in the center of the 24-ply specimens and at the sides of the 16-ply specimens decreases postbuckling strength as impact speed increases. Apparently, the strains at these impact sites are high enough to cause the impact damage to propagate to fail the specimens.

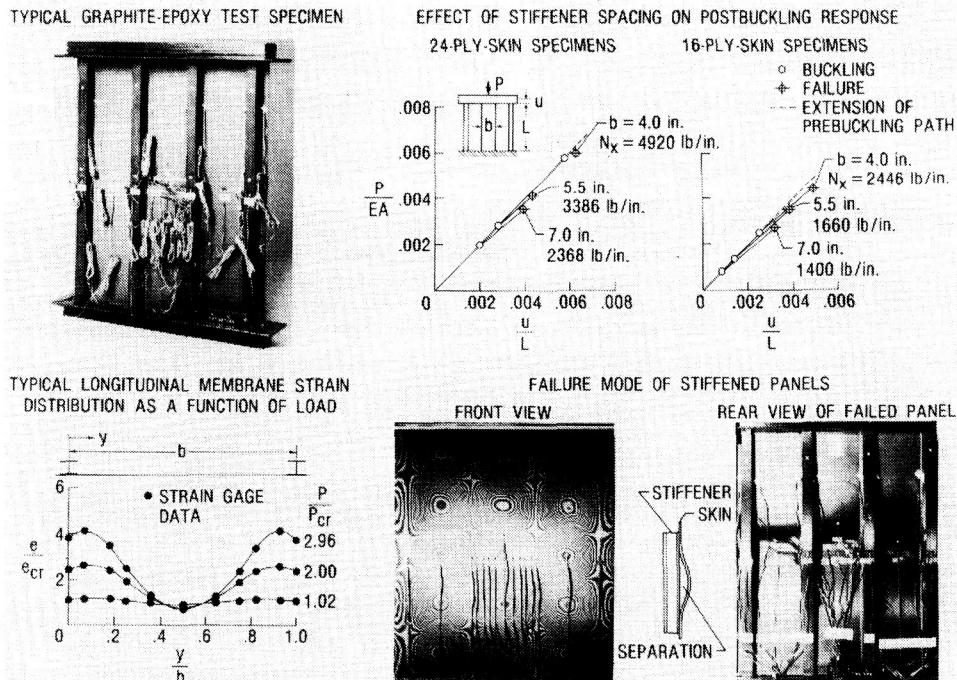
Figure 5

Flat graphite-epoxy stiffened panels were loaded to failure in compression to study their postbuckling behavior (ref. 2). The specimens were made from T300/5208 graphite-epoxy unidirectional tape and had four stiffeners of a common stiffener design. Specimens with 16- and 24-ply skins and 4.0-, 5.5- and 7.0-inch stiffener spacing were tested. A typical specimen is shown in the upper left photograph of Figure 5. Some typical results are also shown in Figure 5. Measured end shortening results u for specimens with various stiffener spacing b and skin thicknesses are shown in the upper figures as a function of the applied load P . End shortening is normalized by the panel length L and the applied load is normalized by the panel longitudinal modulus E and cross-sectional area A . All specimens exhibited some postbuckling capability. The open circles represent buckling and the crossed circles represent failure. The end loadings N_x at failure for the specimens ranged from 1400 lb/in to 4920 lb/in which is representative of transport fuselage loads. Back-to-back strain gages were distributed across the skin of the panels between the two interior stiffeners and some typical membrane strain results e are shown in the lower left figure for several values of applied load. The membrane strain is normalized by the strain at buckling e_{cr} and the applied load is normalized by the buckling load P_{cr} . The results indicate that the strains near the stiffeners are significantly higher than the strains in the center of the skin between stiffeners. All panels failed when the stiffeners separated from the skin as shown in the photograph and sketch at the lower right. Apparently, the high longitudinal strains at the stiffeners (shown in the lower left figure) interact with the out-of-plane deflection gradients at the stiffeners (shown in the lower center photograph of the moire-fringe pattern of out-of-plane displacements) to fail the panels.

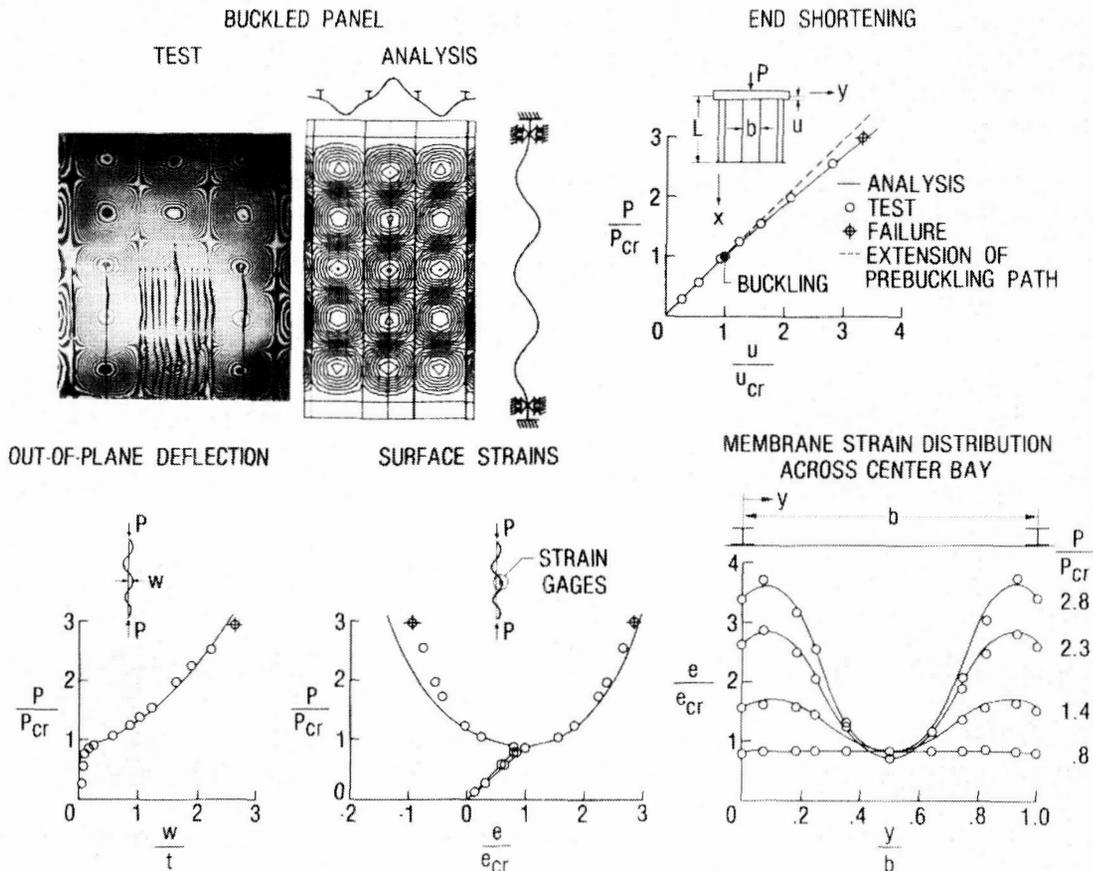
Figure 6

The STAGSC-1 nonlinear structural analysis code (ref. 3) was used in reference 2 to predict the response of a typical panel described in Figure 5 and the results are shown below in Figure 6. The results shown are for a panel with a 16-ply skin and 7.0-inch stiffener spacing. It was necessary to model the stiffener attachment flanges and webs with flexible plate elements in the finite element model used for the analysis in order to obtain the close agreement between test and analysis shown below. The contour plot at the upper left of the figure compares well with the photograph of the moire-fringe pattern of the out-of-plane deflections. The open circles in the figures below are test data and the solid lines are analytical data. The crossed circles represent failure of the specimens. The upper right figure compares results for end shortening u (normalized by end shortening at buckling u_{cr}) as a function of applied load P (normalized by the buckling load P_{cr}). The lower left figure compares results for measured out-of-plane deflection w at a point on the skin (normalized by the skin thickness t) as a function of applied load. The lower center figure compares strain results e from back-to-back strain gages on the skin (normalized by the strain at buckling e_{cr}) as a function of applied load. The lower right figure compares membrane strain distribution results across the panel skin between two stiffeners for several values of applied load. The results indicate that test and analysis compare well up to failure.

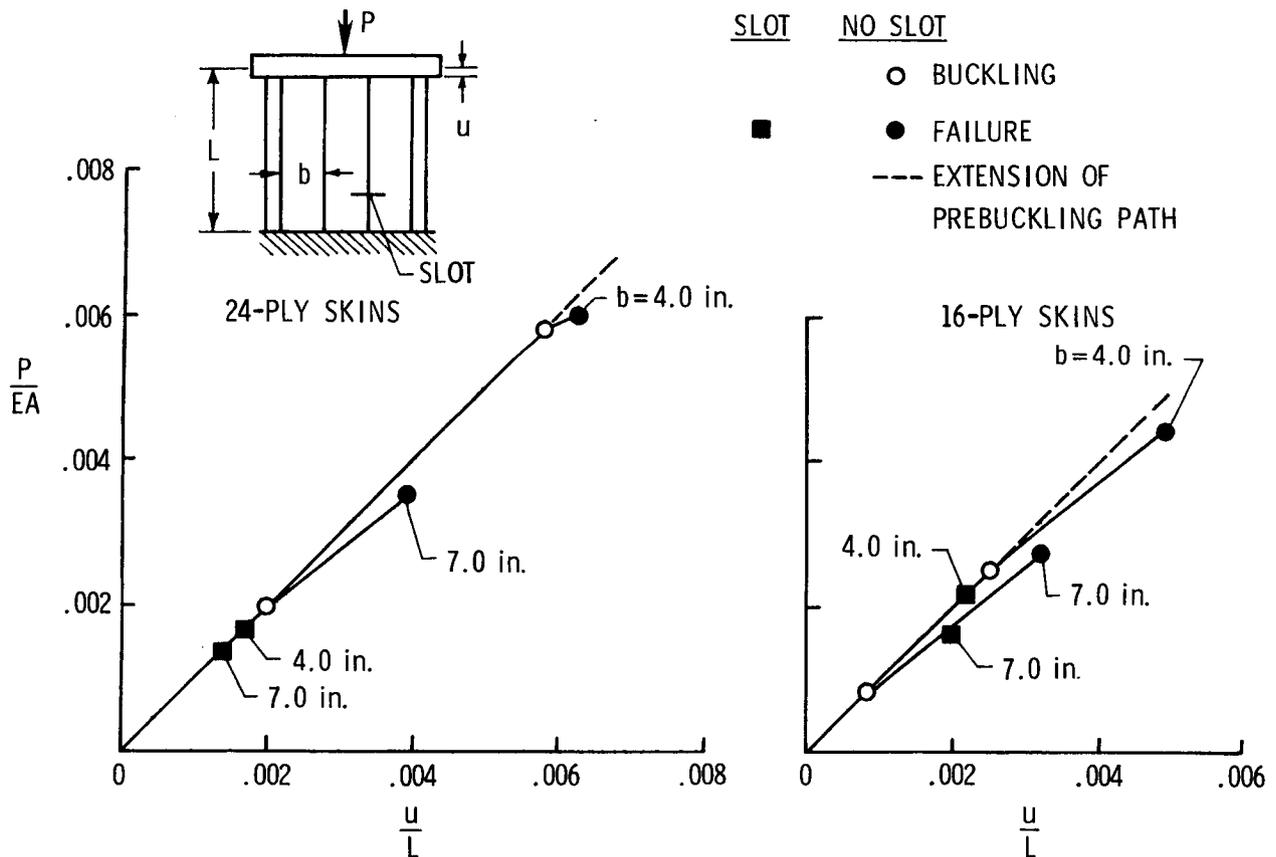
Figure 7

Several T300/5208 graphite-epoxy stiffened panels, similar to those described in Figure 5, were subjected to low-speed impact damage and the results of residual strength tests on these damaged panels are presented in reference 2. It was found in reference 2 that low-speed impact damage could degrade the postbuckling strength of a panel if a region near a stiffener attachment flange were damaged. Several other stiffened panels, similar to those described in Figure 5, were damaged by cutting a 2.0-inch-long slot completely through the skin and one stiffener as indicated by the upper left figure in Figure 7. A slot was cut into panels with 16- and 24-ply skins and 4.0- and 7.0-inch stiffener spacing and then tested to failure to determine their residual strength. The results of these residual strength tests are shown below in Figure 7. End shortening results u (normalized by panel length L) are shown as a function of applied load P (normalized by panel longitudinal modulus E and cross-sectional area A). The results for undamaged specimens from Figure 5 are shown for comparison. The open circles represent panel buckling and the filled circles represent failure of the undamaged panels. The filled squares represent failure of the panels with slots. The results indicate that the slots degraded the postbuckling strength of the panels. The reduction in postbuckling strength observed for the slotted panels was greater than the reduction in postbuckling strength observed for the low-speed impact damaged panels reported in reference 2.

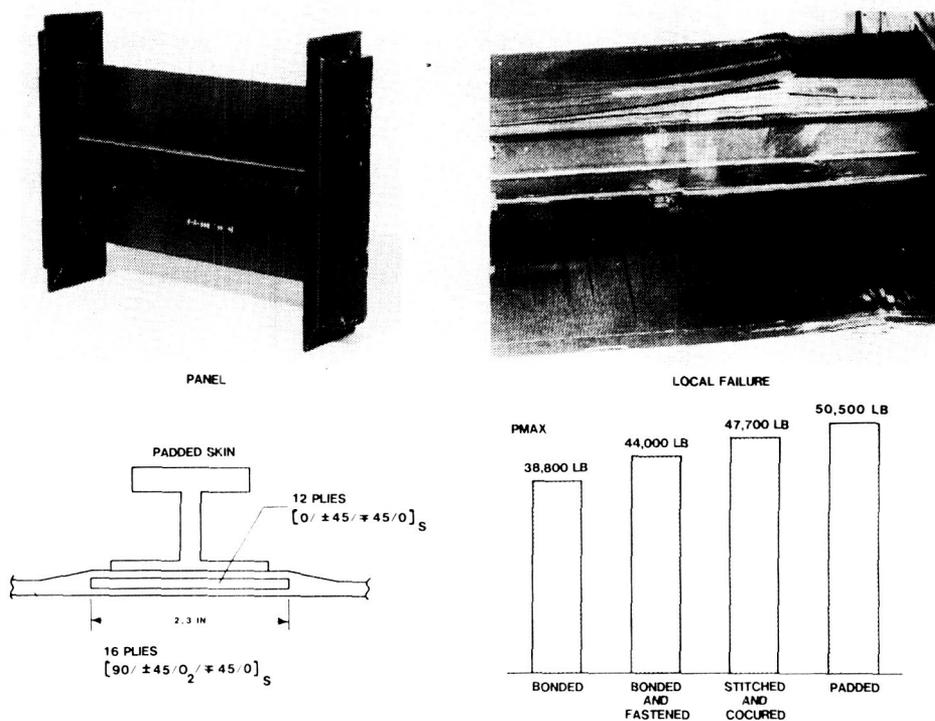
Figure 8

Failure of the stiffened panels described in Figure 5 was caused by separation of the stiffener from the panel skin. Three stiffener attachment concepts that were intended to suppress the skin-stiffener separation failure mode have been evaluated to determine their effectiveness. Four Hercules AS4/3502 graphite-epoxy panels with 16-ply skins were made with a single stiffener attached to a skin with one of four stiffener attachment concepts. A typical specimen is shown in the upper left photograph in Figure 8. One specimen had the stiffener bonded to the skin with a secondary bonding operation to represent the stiffener attachment concept used for the panels described in Figure 5. The second specimen had a bonded stiffener reinforced with mechanical fasteners through the skin and stiffener attachment flanges. The attachment flanges of the third specimen were stitched to the skin and the skin and stiffener were cocured. The fourth specimen was based on the padded skin concept described in reference 4 and includes an additional twelve plies of AS4/3502 tape in the skin under the stiffener as shown in the lower left figure. The four panels were tested to failure and the results of the tests are shown in the lower right figure. The failure loads of the panels with mechanical fasteners and stitching were both higher than the failure load for the panel with the constant-thickness 16-ply skin and bonded stiffener. However, the failure load of the panel with the padded skin was higher than the failure loads of the other three panels. While the panel with the padded skin was approximately nine percent heavier than the panel with the bonded stiffener, its failure load was 30 percent higher. The panel with the padded skin failed by stiffener crippling as shown in the upper right photograph rather than by skin-stiffener separation.

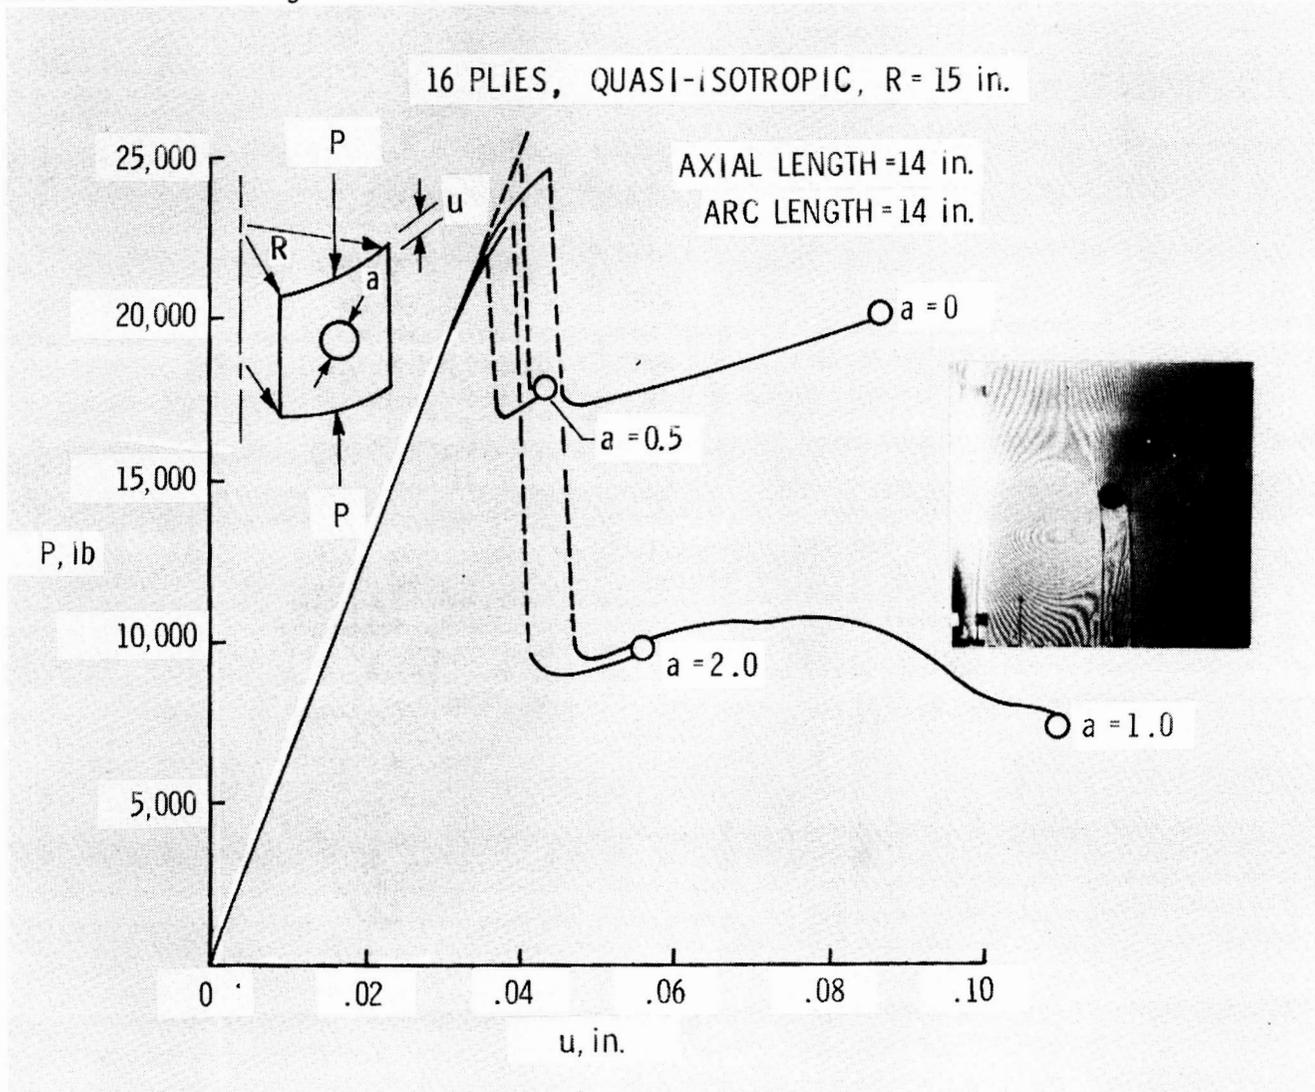
Figure 9

The effect of circular holes on the postbuckling response of curved T300/5208 graphite-epoxy panels is shown below in Figure 9. The results are for 16-ply quasi-isotropic panels with a 15 inch radius. The panels are 14 inches long and have a 14 inch arc length. Panels with no hole and with 0.5-, 1.0- and 2.0-inch-diameter holes were tested to failure. The panels were tested in a manner similar to that described for the panels in Figure 1. All panels exhibited some postbuckling capability. As shown in the figure, the panel with no hole ($a = 0$) and the panel with the 0.5-inch-diameter hole supported higher postbuckling loads than the panels with 1.0- and 2.0-inch-diameter holes. Severe local bending occurs near the hole after buckling as indicated in the photograph of the moire-fringe pattern of the buckling mode of the panel with the 1.0-inch-diameter hole. This severe local bending caused delamination to occur at the hole edge as shown in the photograph of the 2.0-inch-diameter hole edge shown in Figure 10. Apparently, the delamination at the hole edge reduced the local stiffness of the panel enough to reduce the postbuckling strength of the panels with the larger holes.

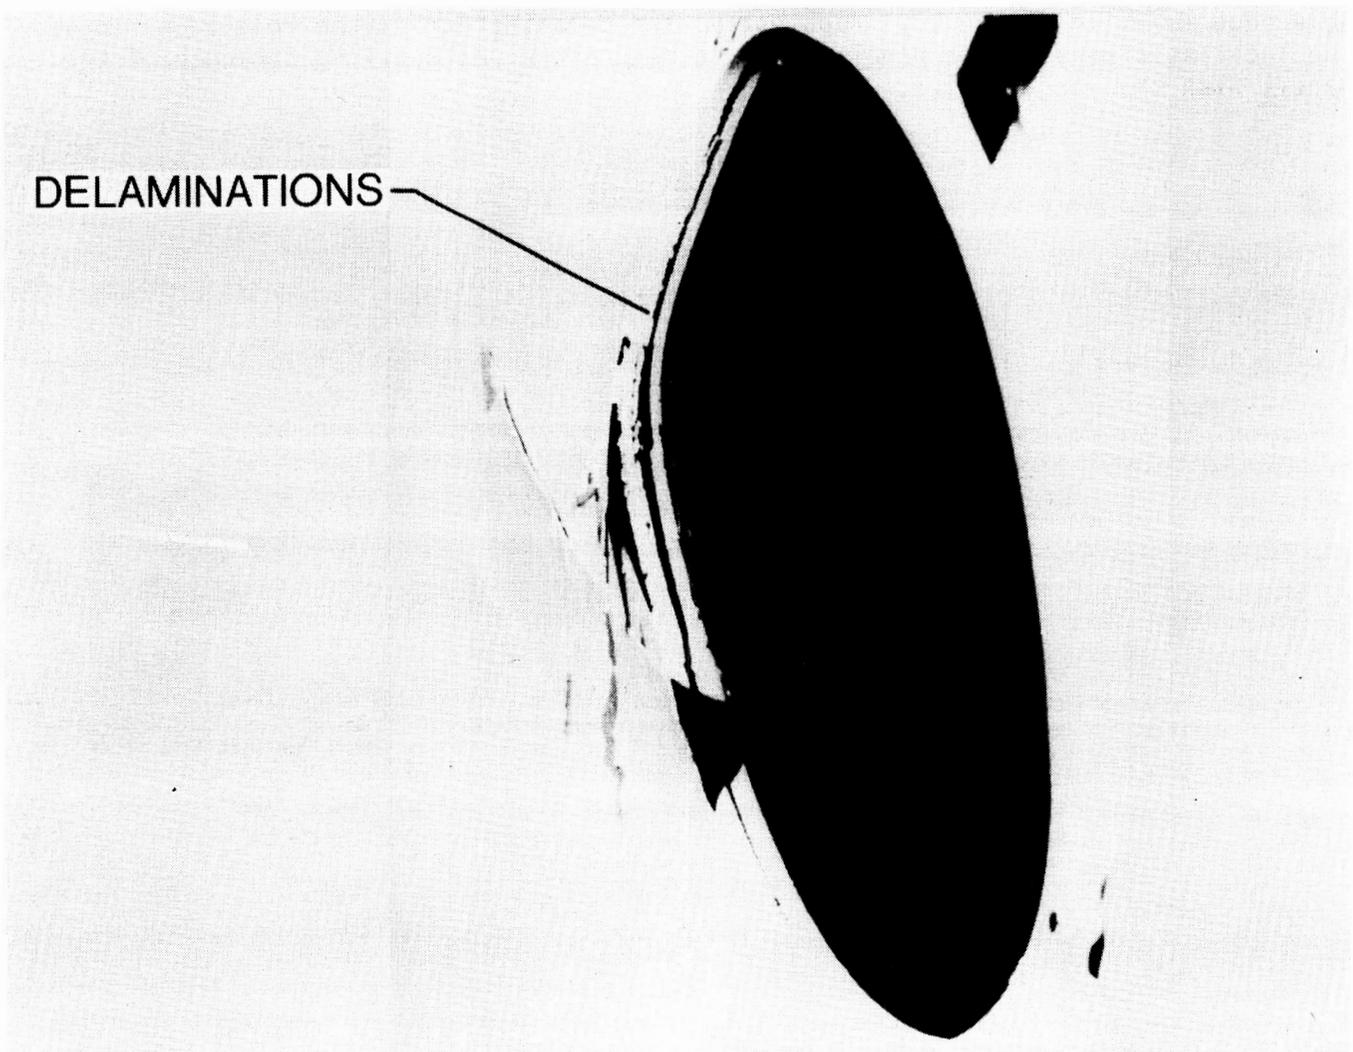
Figure 10

The delaminated hole edge of the panel with the 2.0-inch-diameter hole described in Figure 9 is shown in Figure 10.

16-PLY PANEL, 2.0-IN.-DIAMETER HOLE, R = 15 IN.

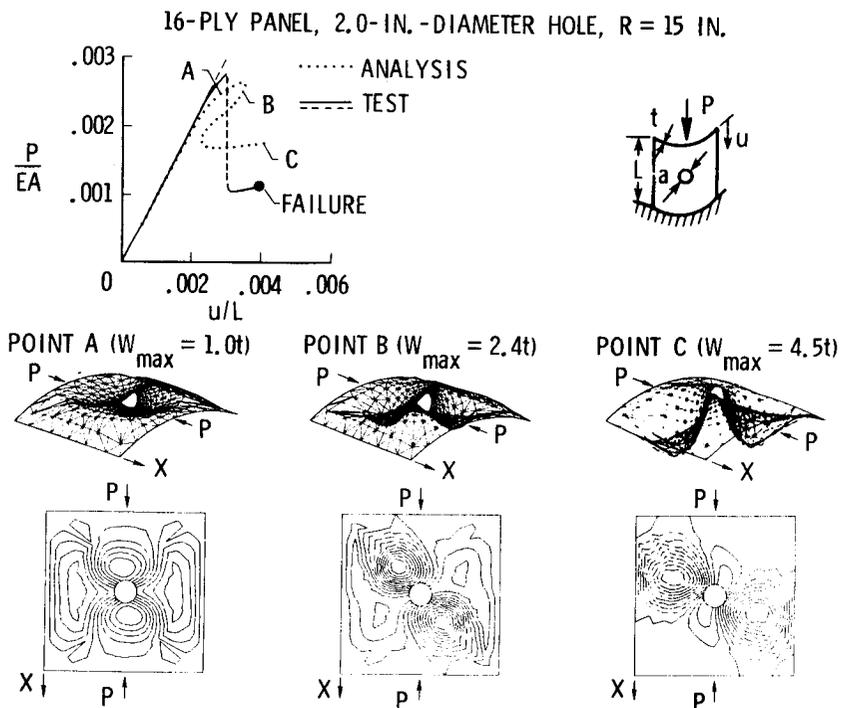
Figure 11

The STAGSC-1 nonlinear structural analysis code (ref. 3) was used in reference 5 to analyze the postbuckling response of the curved T300/5208 panel with a 2.0-inch-diameter hole described in Figure 9. The analytical results are compared with the test results in the upper left figure in Figure 11. The end shortening u (normalized by the panel length L) is shown as a function of the applied load P (normalized by the panel longitudinal modulus E and cross-sectional area A). Test and analysis compare reasonably well until the buckling load is approached. Near buckling the analysis predicts large symmetric local radial deflections w near the hole as indicated by the lower left contour and deformed shape plots for the load corresponding to point A on the upper left figure. An arc-length projection method (ref. 6) was used to continue the analysis past the limit point and onto the unstable postbuckling equilibrium path. After buckling the analysis predicts severe local bending and large nonsymmetric radial deflections near the hole as indicated by the lower center contour and deformed shape plots for the load corresponding to point B on the upper left figure. On the stable postbuckling equilibrium path, the analysis again predicts severe local bending and large nonsymmetric radial deflections as indicated by the lower right contour and deformed shape plots for the load corresponding to point C on the upper left figure. Apparently, the severe local bending near the hole causes sufficiently large surface rotations to exceed the capability of the moderate rotation formulation used in STAGSC-1. Also, this severe local bending apparently causes enough local transverse shearing deformations to delaminate the panel at the edge of the hole as shown in Figure 10. Once delamination occurs, the finite element model does not accurately represent the panel near the hole.

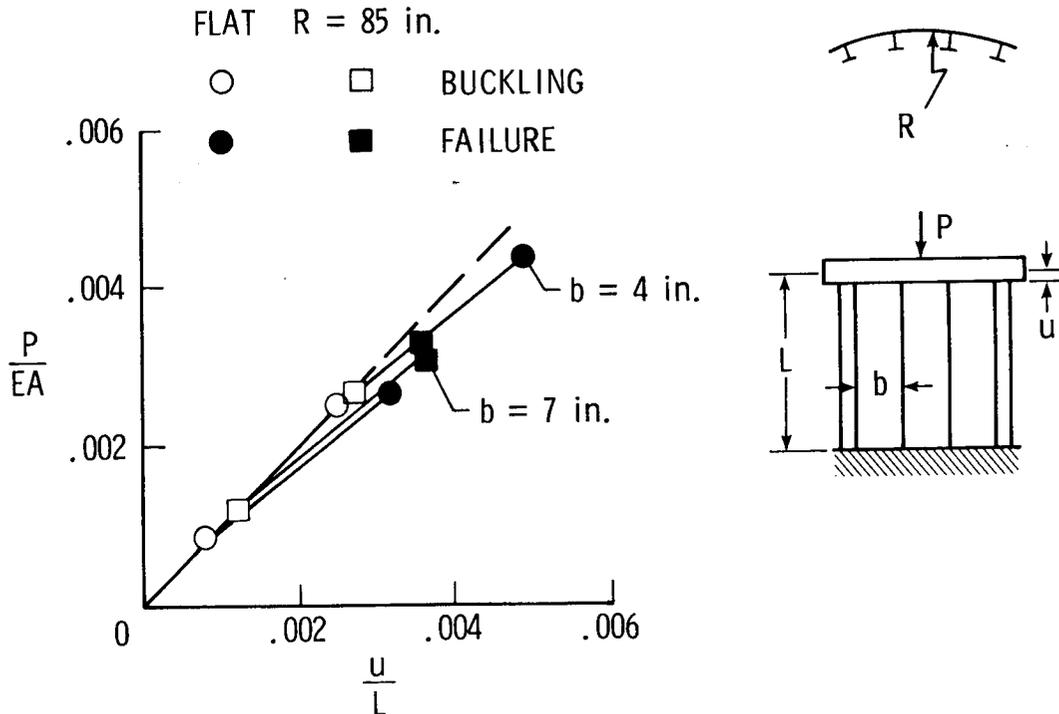
Figure 12

Curved graphite-epoxy stiffened panels were loaded to failure in compression to study their postbuckling behavior. The panels were made from T300/5208 graphite-epoxy tape and had an 85 inch radius. The panels had the same 16-ply-skin and stiffener designs as the flat panels described in Figure 5 and had a 4.0- or 7.0-inch stiffener spacing. The results of the tests of these panels are shown in Figure 12. End shortening results u (normalized by panel length L) are shown as a function of the applied load P (normalized by the panel longitudinal modulus E and cross-sectional area A). The results for the corresponding flat specimens from Figure 5 are shown for comparison. The square symbols represent the curved panel results and the circles represent the flat panels. The open symbols represent buckling and the filled symbols represent failure. As expected, buckling loads for both curved panels are higher than for the corresponding flat panels. However, the flat panel with 4.0-inch stiffener spacing failed at a higher load than the corresponding curved panel, and the curved panel with the 7.0-inch stiffener spacing failed at a higher load than the corresponding flat panel. Additional testing and analyses are currently being conducted to resolve this apparent anomaly.

16-PLY SKINS

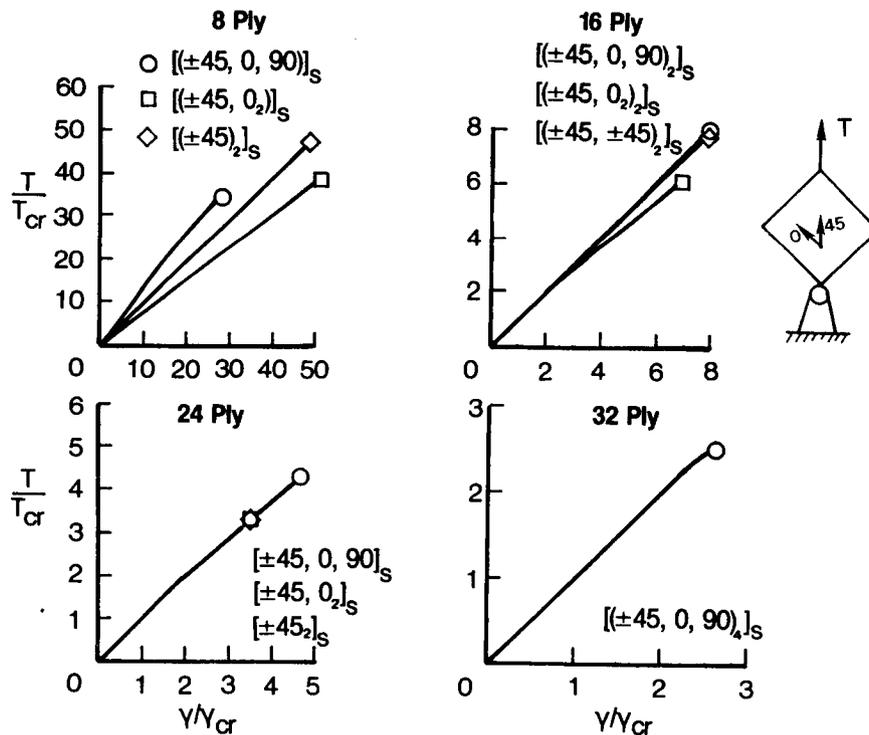
Figure 13

Flat unstiffened shear webs were loaded to failure in shear to study their postbuckling behavior and failure characteristics. The results of this study of unstiffened shear webs are part of the research being conducted by the third author to fulfil the requirements for the degree of Master of Science from the School of Engineering and Applied Science of George Washington University. Unidirectional tapes of Hercules AS4 graphite fibers and 3502 epoxy resin (AS4/3502) were used to make 8-, 16-, and 24-ply webs with quasi-isotropic, orthotropic, and all-+45 stacking sequences. All of the webs had 12.0-inch by 12.0-inch test sections and were tested in a picture-frame shear fixture.

Membrane shear strain results are shown in figure 13. The applied load T is normalized by the applied load at buckling T_{Cr} and the membrane shear strain γ is normalized by the membrane shear strain at buckling γ_{Cr} . The open symbols indicate failure of the webs. The failure loads of the 8- and 16-ply webs were approximately 50 and 8 times the buckling load, respectively. The failure loads of the 24- and 32-ply webs were approximately 4.5 and 2.5 times the buckling load, respectively. There was a significant reduction in postbuckling stiffness as indicated by the change in slope of the postbuckling curves when the stacking sequence of the 8-ply webs was changed from a quasi-isotropic to an all-+45 laminate. The 16-ply quasi-isotropic and orthotropic webs had essentially the same postbuckling stiffness, but the all-+45 webs had a slightly lower postbuckling stiffness. The 24-ply webs had essentially the same postbuckling stiffness. Test results indicate that laminate stacking sequence and thickness can influence the postbuckling stiffness and strength of graphite-epoxy shear webs.

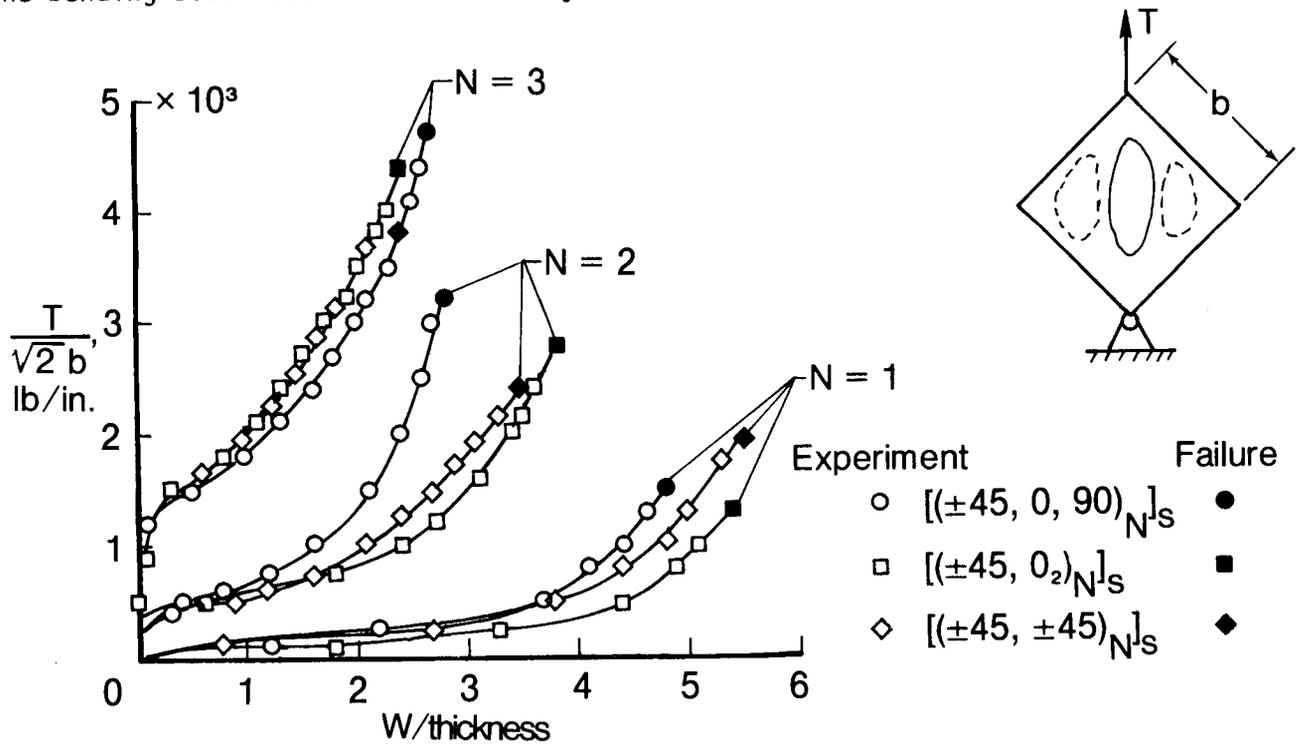
Out-of-plane deflections measured near a point of maximum buckling-mode amplitude are shown in Figure 14 for the 8-, 16-, and 24-ply webs described in Figure 13. The applied shear flow ($T/\sqrt{2}b$) is plotted on the vertical axis and the out-of-plane deflection w normalized by the web thickness is plotted on the horizontal axis. The symbols represent test data for the various laminates defined in the figure. The filled symbols indicate failure. The 8-ply webs had maximum out-of-plane deflections at failure of over five times the thickness. There was significant reduction in the maximum deflection when the thickness of the specimen was increased from 8 plies to 16 plies and a further reduction when the thickness was increased to 24 plies. The results shown in the figure indicate that a significant amount of bending can occur when a graphite-epoxy shear web is loaded into the postbuckling range and the bending stiffness is influenced by the thickness.

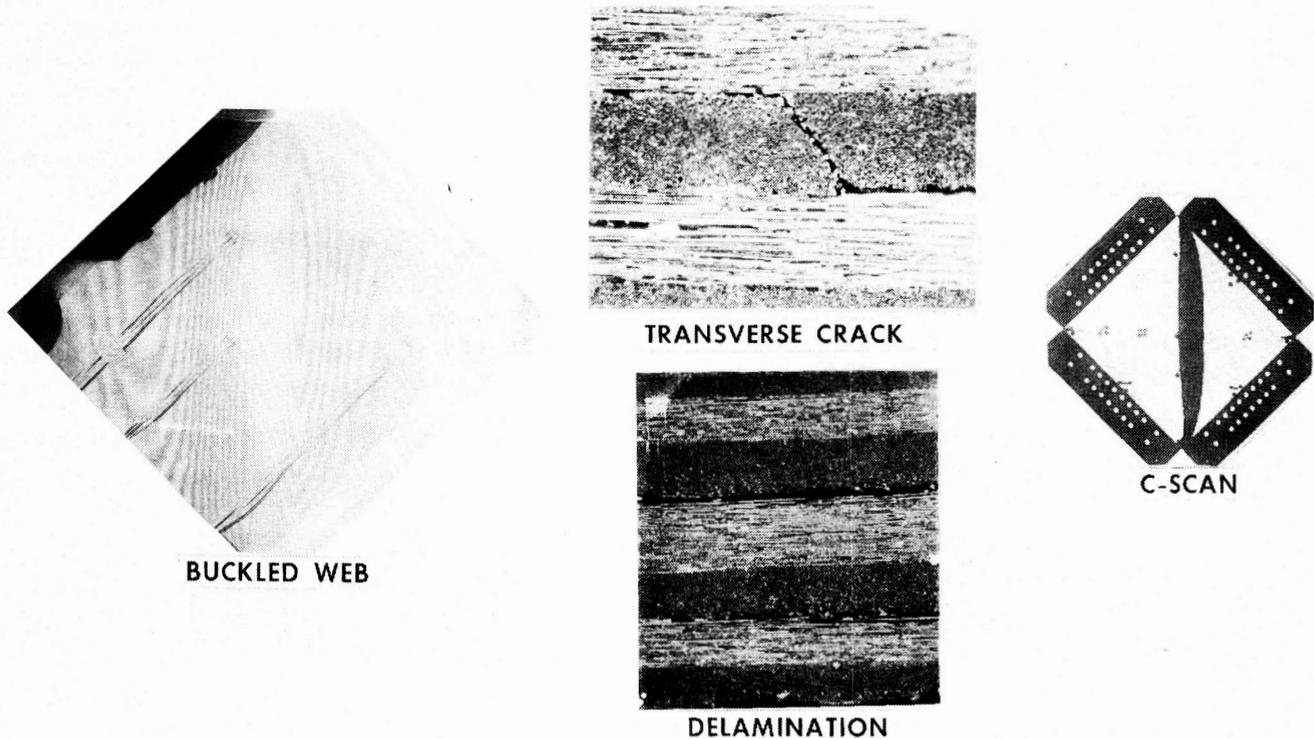
Figure 15

Some failure characteristics of an 8-ply shear web that was loaded into the postbuckling range are shown in Figure 15. The specimen was loaded well into the postbuckling range and then unloaded for inspection. The photograph on the left shows the moire-fringe pattern of the buckled web at its maximum load. The panel was cross sectioned so the interior could be examined. The center photographs show a cross section of the web. The photograph on the right shows the results of an ultrasonic C-scan inspection of the web.

The photograph of the moire-fringe pattern indicates that a high displacement gradient occurred near the center of the web prior to failure. The photograph of the ultrasonic C-scan indicates that a delamination had occurred in the web. The center photographs show a transverse crack in the laminate and a delamination between plies. Results for 8-ply shear webs indicate that delamination may be a failure mode limiting the postbuckling strength of a graphite-epoxy shear web.

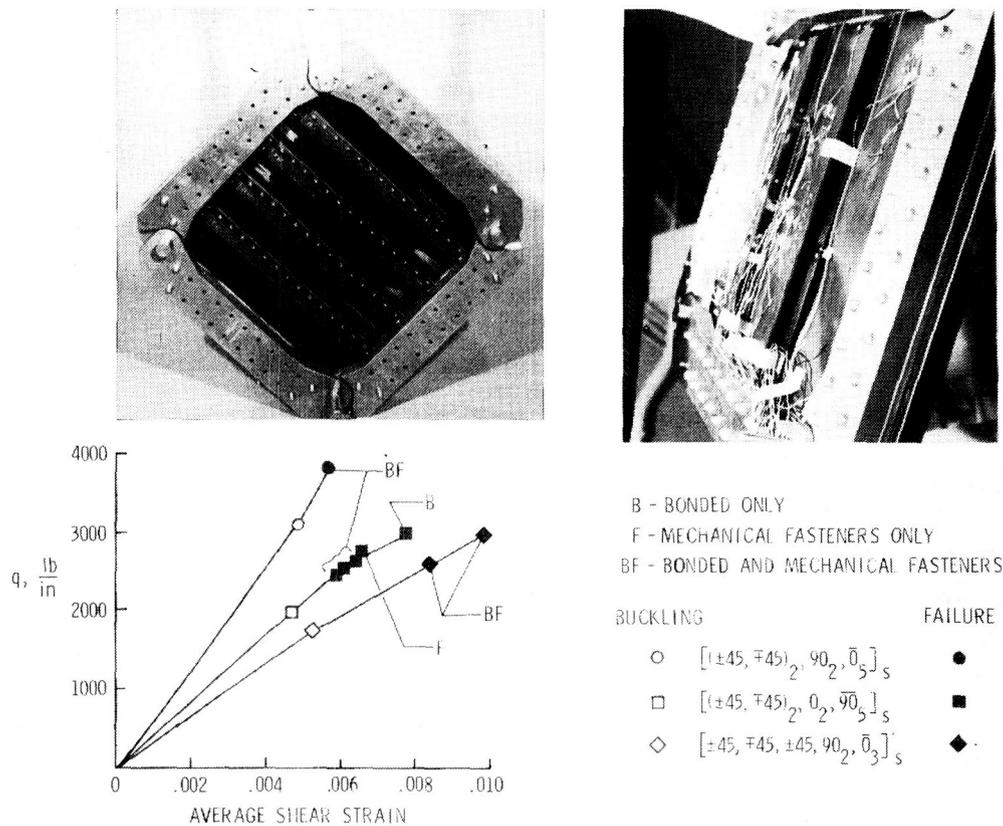
Flat stiffened graphite-epoxy shear webs were loaded to failure in shear to study their postbuckling behavior. Unidirectional tapes of Hercules AS4/3502 graphite-epoxy were used to make 19-, 25-, and 33-ply shear webs. All of the shear webs had 22.5-inch by 22.5-inch test sections. The 19-ply shear webs had a 4.5-inch stiffener spacing and the 25- and 33-ply webs had a 7.5-inch stiffener spacing. There was a common stiffener design for all of the webs that were tested. The stiffeners were attached to the skins with mechanical fasteners and/or bonding. A photograph of a 19-ply shear web is shown in the upper left of Figure 16.

Membrane shear strain results from the tests are summarized below in the lower left of Figure 16. The applied shear flow q is plotted as a function of membrane shear strain. Buckling is indicated by the open symbols and the filled symbols indicate failure. All of the shear webs exhibited some postbuckling capability. The 33-ply shear webs failed soon after buckling. The 19- and 25-ply shear webs had more postbuckling response after buckling. Test results for 25-ply shear webs indicate that specimens with mechanically fastened stiffeners did not exhibit significant improvements in postbuckling performance compared to the specimen with adhesively bonded stiffeners. An improved fastener concept did improve the postbuckling performance of 19-ply shear webs with mechanically fastened and adhesively bonded stiffeners. The photograph in the upper right of Figure 16 shows the typical failure mode for all of the shear webs. These specimens failed when the stiffeners separated from the skin along the skin-stiffener interface.

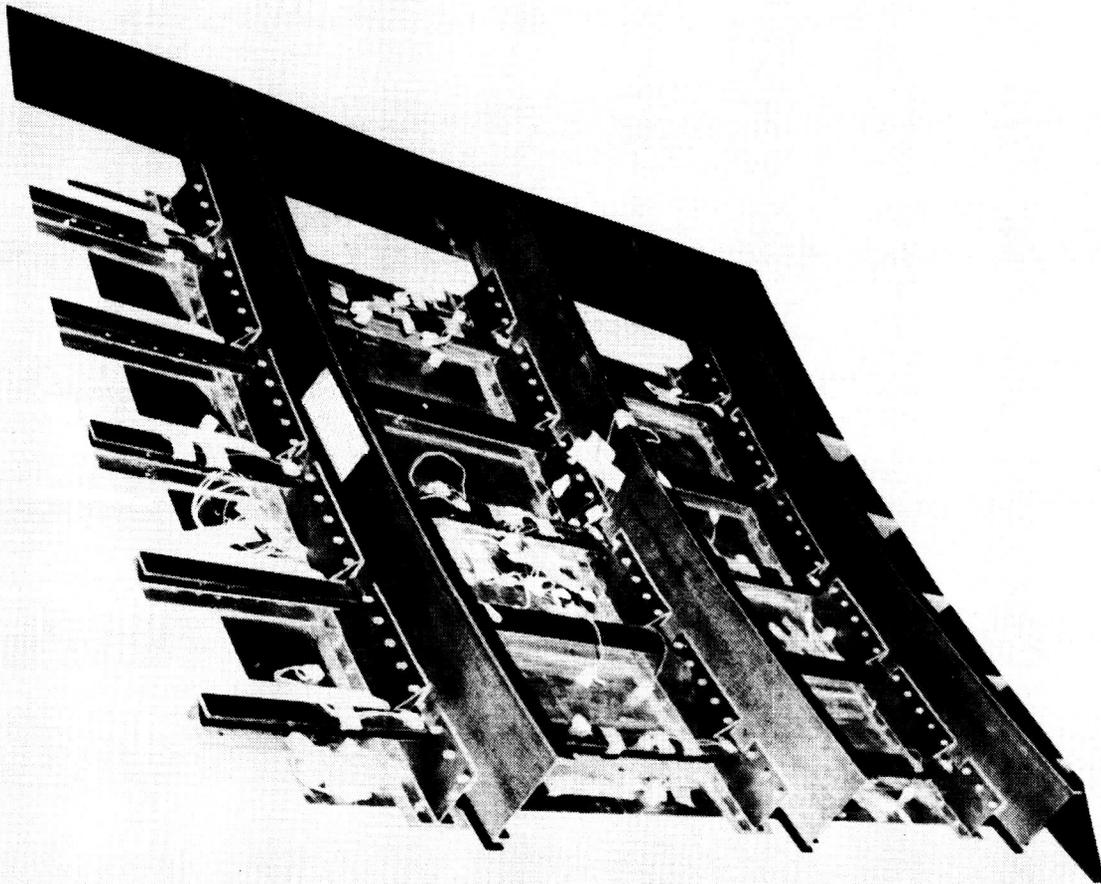
Curved AS4/3502 graphite-epoxy stiffened panels were loaded to failure in shear and combined shear and compression to study their postbuckling behavior. The panel designs were based on a minimum-weight buckled-skin design obtained from the POSTOP structural optimization code (ref. 7) and had both stiffeners and frames as indicated in Figure 17 below. The padded-skin stiffener attachment concept described in Figure 8 was used at each stiffener location and a failsafe strap was included under each frame and midway between each frame. The panels were 60 inches long, 42 inches wide and had a 143 inch radius. The panels were mounted in a D-box type fixture to provide a closed torque box suitable for shear loading and tested in the Lockheed-Georgia Company's multi-axis combined load test machine.
